FRANCIS E. WALTER DAM

CONDITION REPORT

DAM, OUTLET WORKS & SPILLWAY
PERIODIC INSPECTION REPORT NO. 3

NOVEMBER 1976

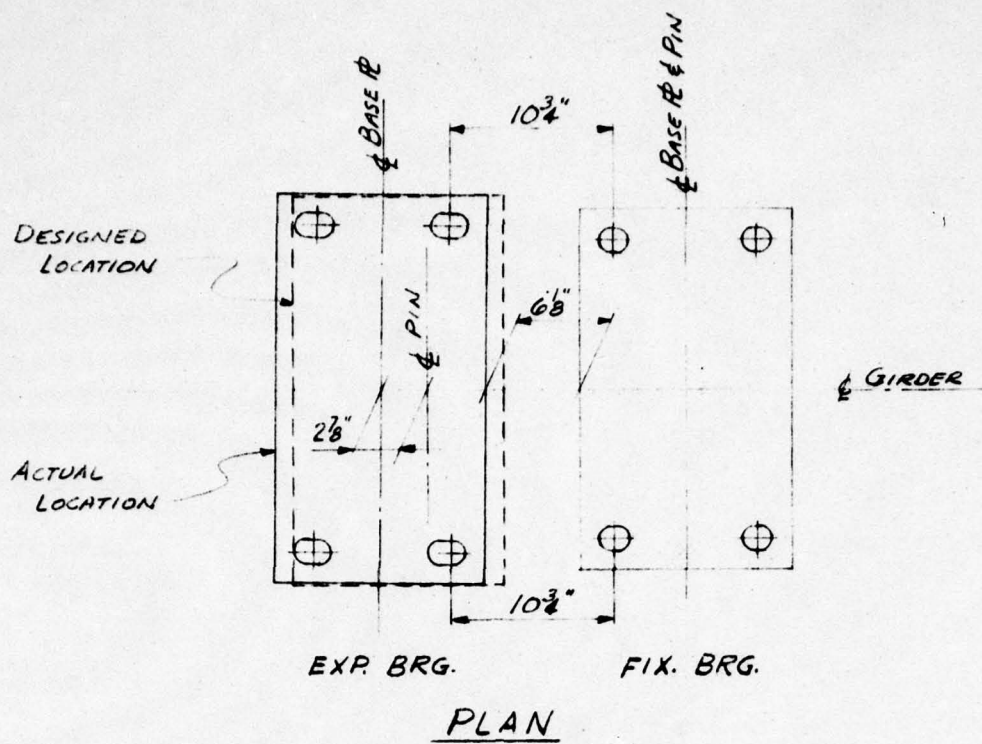
PIER NO. 2 - EAST SIDE
50°F 30 SEPT 1975

a. Bearings (on service bridge to intake tower) - During the summer of 1975, the rockers of both center span expansion bearings on pier No. 2, the pier closest to dam centerline, were observed to be misaligned longitudinally with their base plates and to be in a rotated position limiting span movement due to thermal contraction.

Another method to be considered would also require jacking of the girders, allowing repositioning of the expansion shoes on the girder ends to align vertically with the base plates. This would entail removal of shoe mounting bolts and interfering rivets and welding of the shoes in the new position. Relocation or addition of end stiffeners might also be required. This method would eliminate the slight eccentricity occurring on the pier cap from dead load reactions under the present condition.

b. Monitoring. It is recommended that a monthly record of changes in gap width between deck joint cover plates, using established punch marks as reference points, be obtained for a period of one year to provide full record of movement as a base for future observations. It is further recommended that, prior to and in conjunction with each periodic (5 year) inspection, a survey be made to check alignment of the punch marks and elevations on the pier and tower bench marks previously established (Exhibit 1, Appendix B). Additional bench marks should be established and elevations recorded on the deck and abutment. Copies of all data obtained should be forwarded to Design Branch, Engineering Division for evaluation and recording.

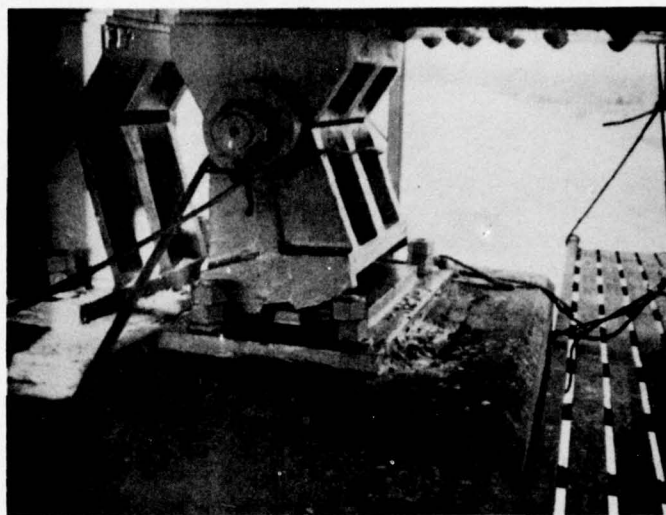
PIER NO. 2-WEST SIDE
EXPANSION BEARING (RIGHT) SEEN FROM INSIDE GIRDER
PHOTO #7

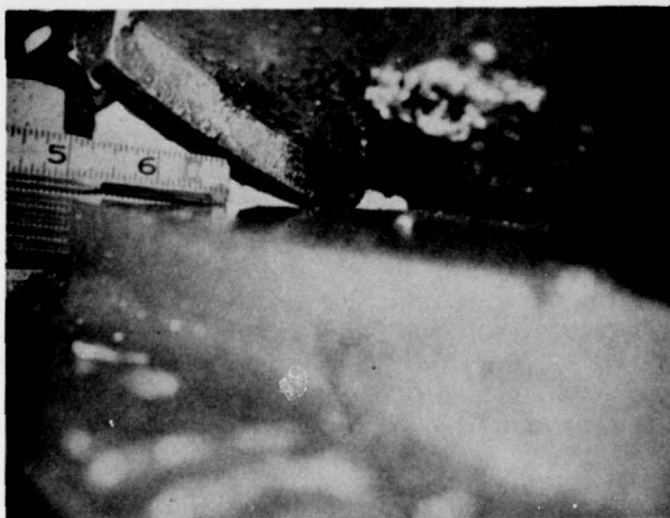
PIER NO. 2-WEST SIDE
CLOSE-UP OF BEARING SURFACES OF ROCKER AND BASE
PLATE SHOWING CONTACT LINE TO RIGHT OF CENTER
PHOTO # 12
